Photographic Log

Facility Name:	Site Location:	Tracking No.:	Date:
Shelby Farms Park, Heart of the Park	Shelby Farms Park	TN0081663	12/11/2015

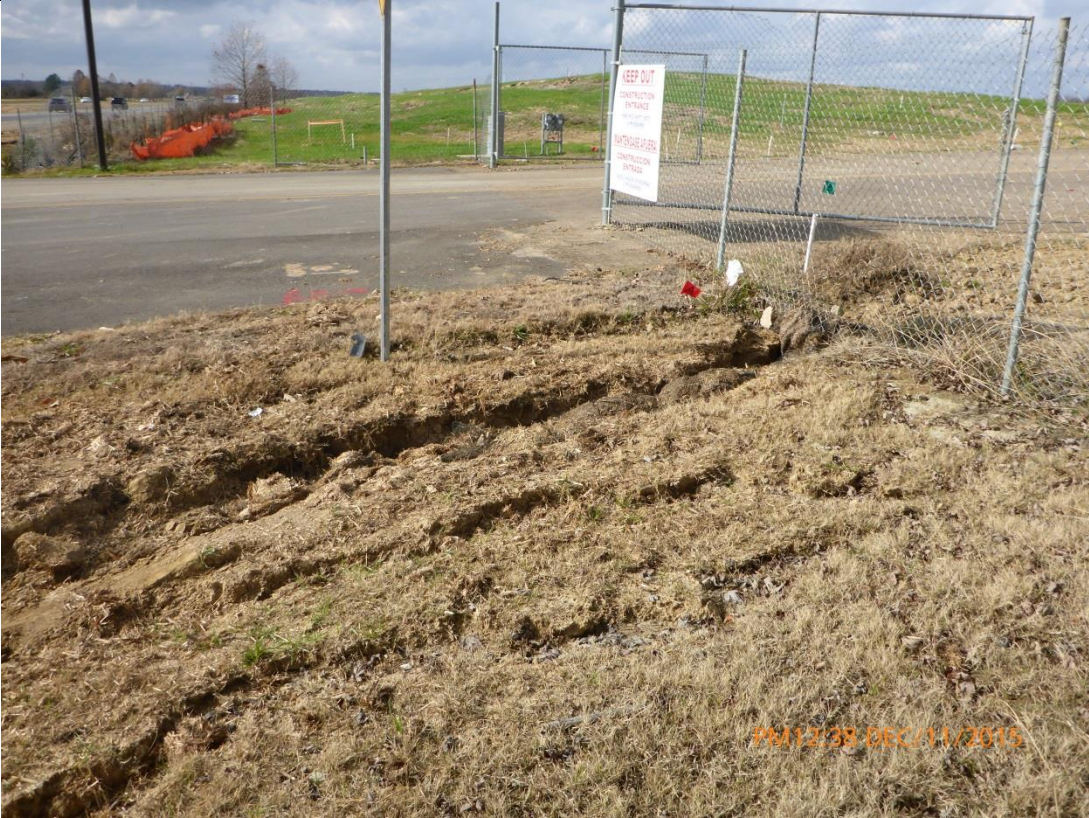
Photo 2. Several gullies have formed near the driveway adjacent to outfall SW5.

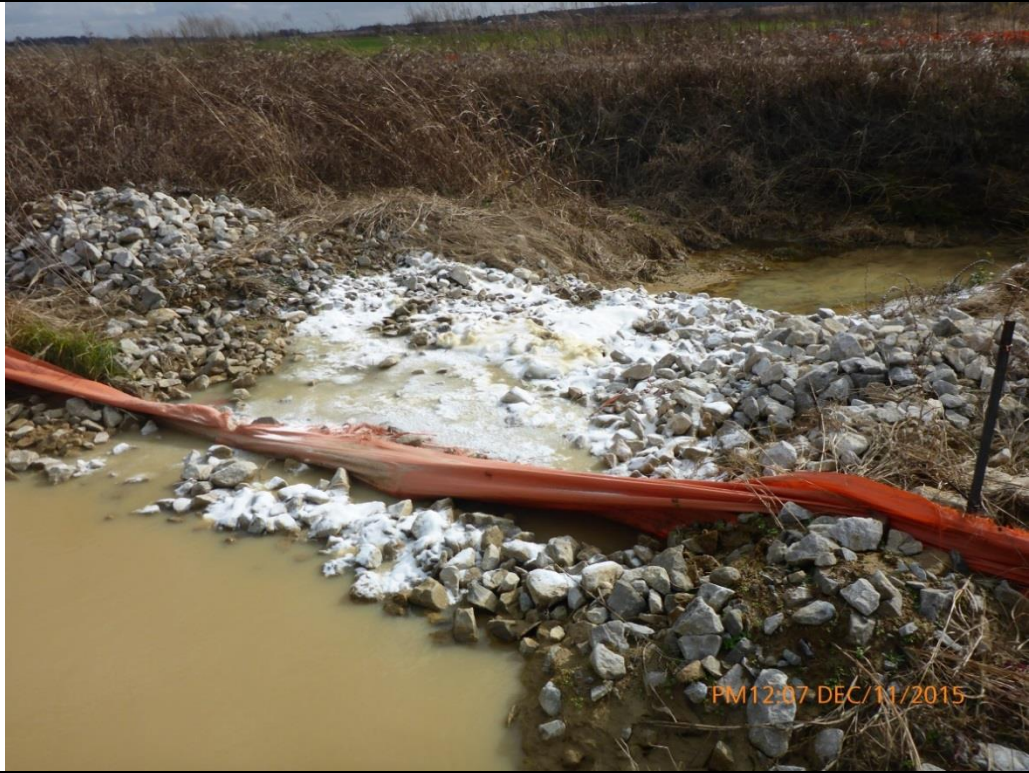
Photo 3. Polyacrylamide (PAM) applied to the rock check dam downgradient of outlet for the Lot 10 sediment basin near outfall SW8. Applying PAM downgradient of the sediment basin is prohibited in the <i>TN Erosion Prevention and Sediment Control Handbook</i> .

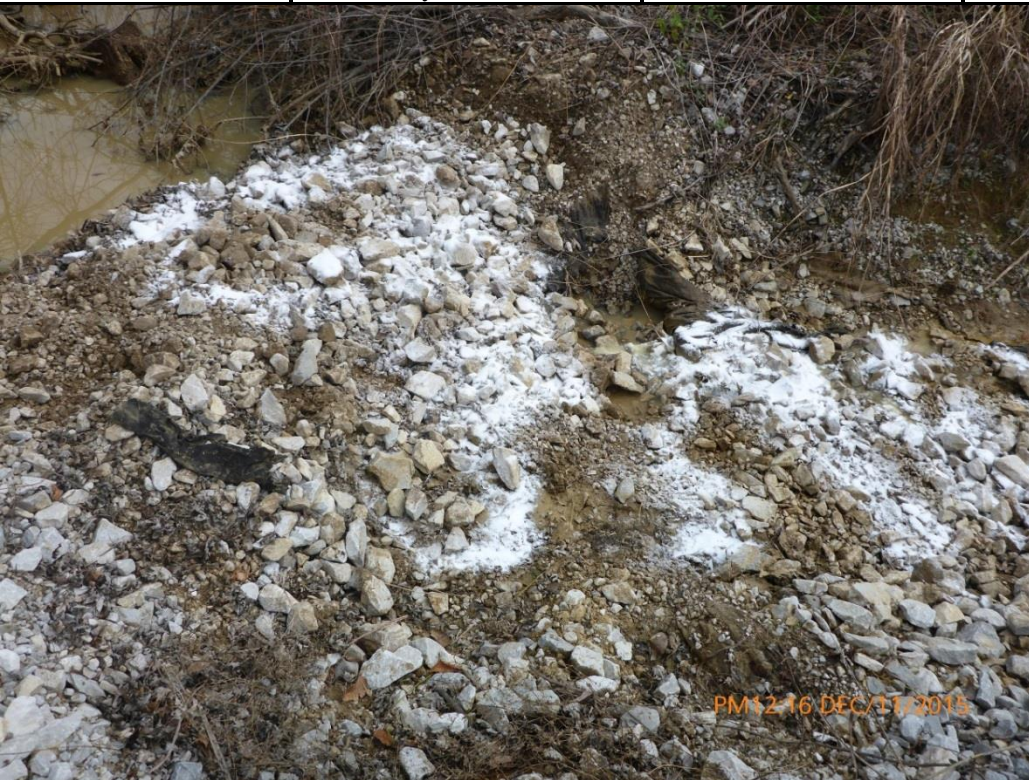
Photo 4. Polyacrylamide (PAM) applied to the rock check dam in the channel downgradient of outfall SW9. Applying PAM downgradient of the sediment basin is prohibited in the <i>TN Erosion Prevention and Sediment Control Handbook</i> .

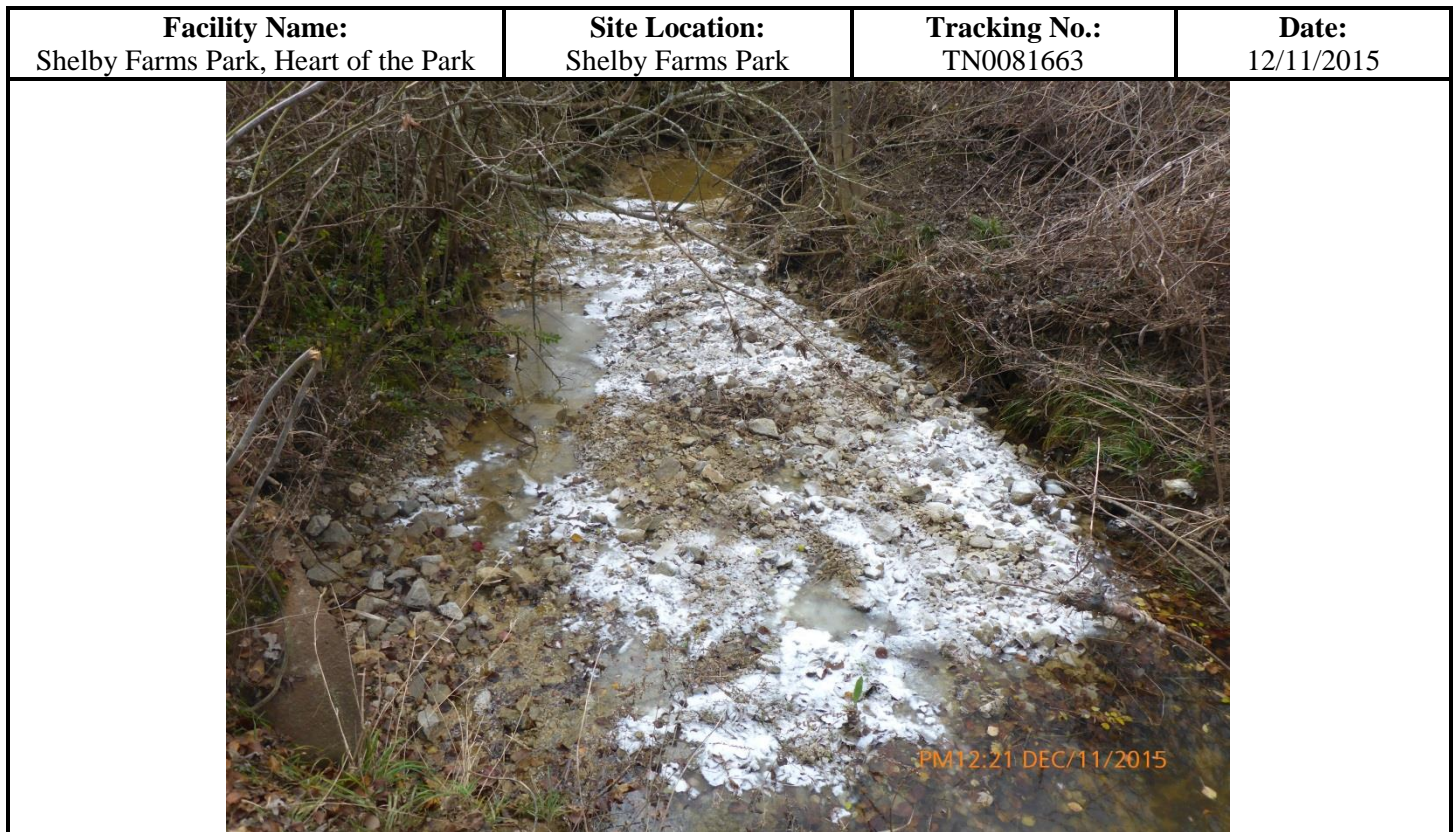
Photo 5. Polyacrylamide (PAM) applied directly into the channel downgradient of outfall SW9. Applying PAM downgradient of the sediment basin is prohibited in the *TN Erosion Prevention and Sediment Control Handbook*.

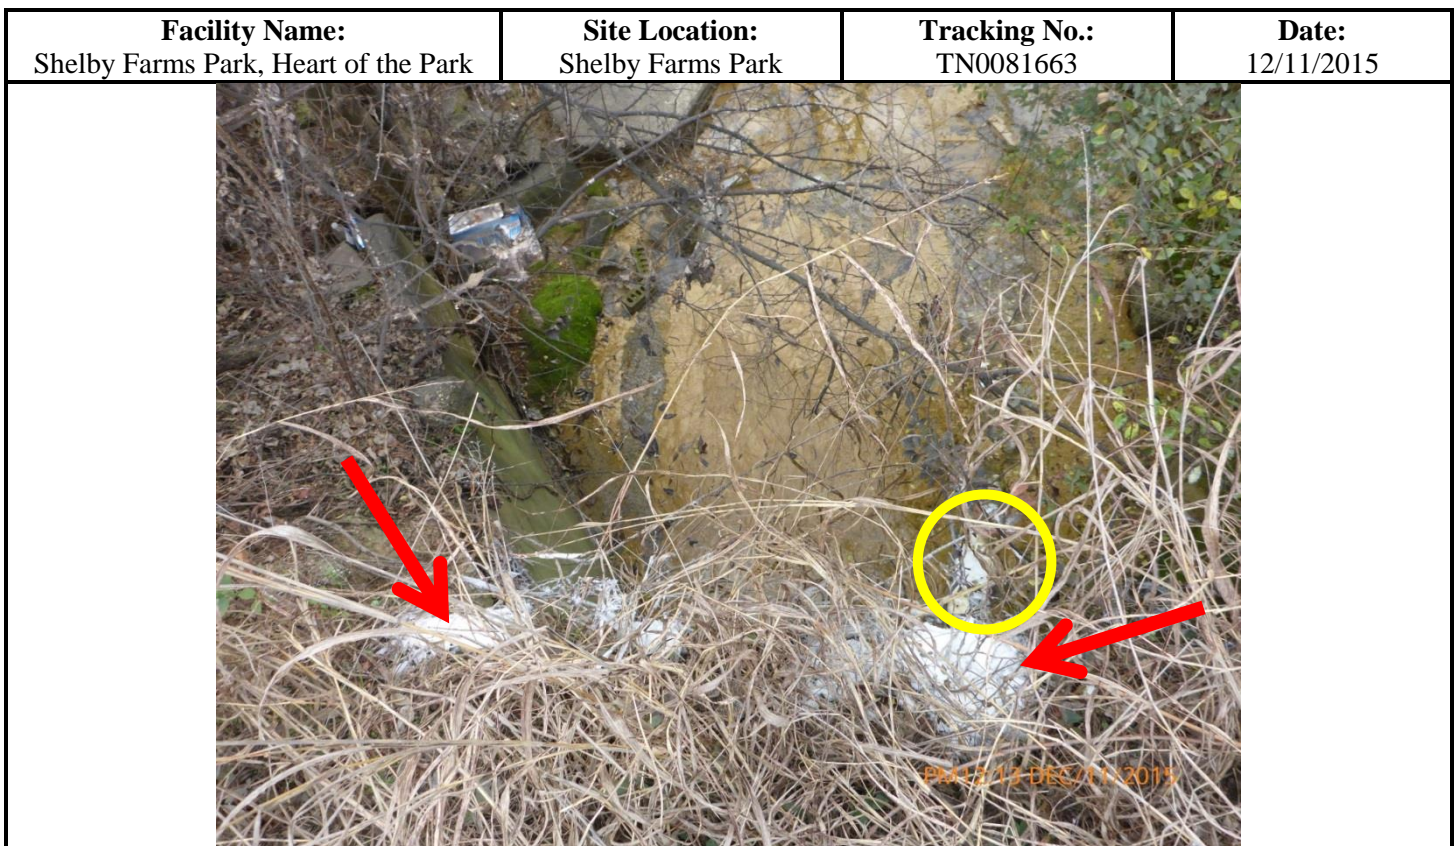
Photo 6. Residual polyacrylamide (PAM) on the top of the ground above the drainage culvert where it was applied to the drainageway downgradient of outfall SW9. Some PAM can also be seen within the channel (yellow circle). Applying PAM downgradient of the sediment basin is prohibited in the *TN Erosion Prevention and Sediment Control Handbook*.
